ControlLogix Enhanced Redundancy System, Revision 20.058_kit2

Redundancy Module Catalog Numbers
1756-RM, 1756-RMXT, 1756-RM2, 1756-RM2XT

Controller Catalog Numbers
1756-L61, 1756-L62, 1756-L63, 1756-L63XT, 1756-L64, 1756-L65, 1756-L71, 1756-L72, 1756-L73, 1756-L73XT,
1756-L74, 1756-L75

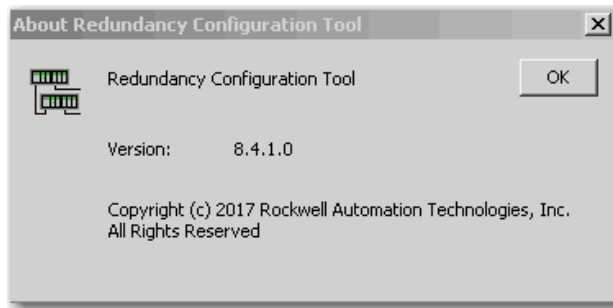
This enhanced redundancy system revision requires the RMCT, version 8.04.01.00 that is packaged with this enhanced redundancy system revision bundle. The About screen for the RMCT displays 8.4.1.0 but it is the correct version.

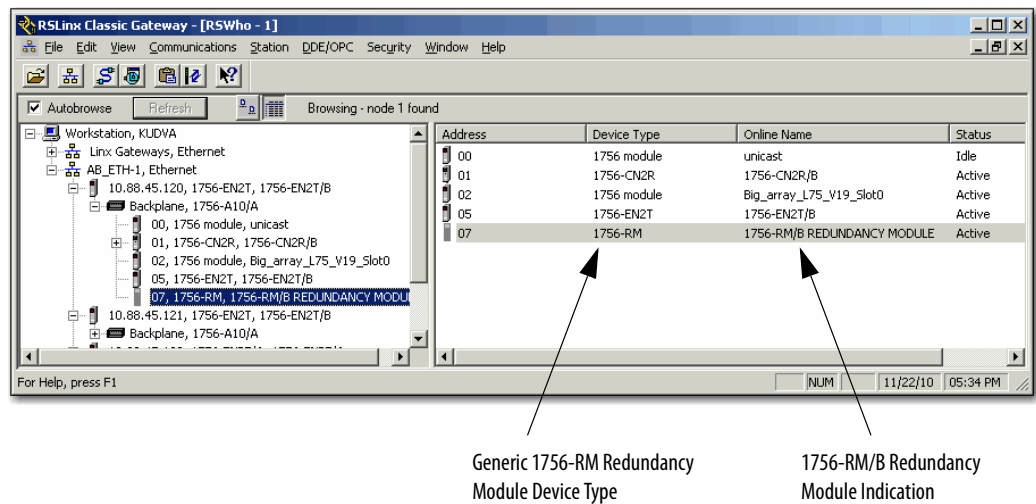
We recommend that you use the EDS file for redundancy modules that is included with the enhanced redundancy system, revision 20.054_kit1 firmware bundle. With the new EDS file, the RSWho software Device Type column shows a generic 1756-RM device type, as shown in this graphic.

1756-RM2/B modules and 1756-RM2XT/B modules appear as series A modules in the Device Type column of an RSWho browse screen. This condition occurs if you use the EDS files available with enhanced redundancy system, revision 16.081, in an enhanced redundancy system, firmware revision 20.054.

In this case, use the information in the Online Name column to identify the series level of your redundancy modules. The information in the Online Name column is accurate.

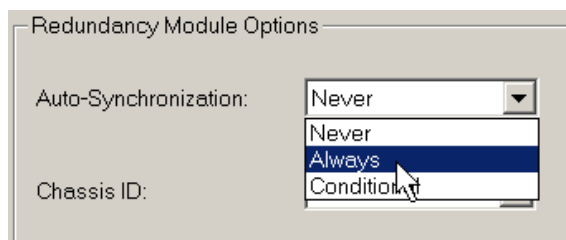
1. Using the Redundancy Module Configuration Tool (RMCT):
 - a. Set Auto-qualification to Never.
 - b. Disqualify the redundant chassis pair (if not already disqualified).
2. Remove the module from the secondary chassis and replace it with the new module.
3. If applicable, update the module firmware by using ControlFLASH.
4. In the RMCT, from the Auto-Synchronization pull-down menu, choose your preferred method.

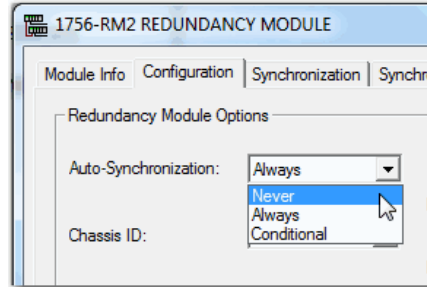
- On the Configuration tab, from the Auto-Synchronization pull-down menu, choose Never.

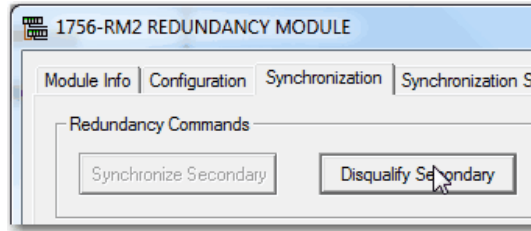
9. On the Synchronization tab, click Disqualify Secondary.

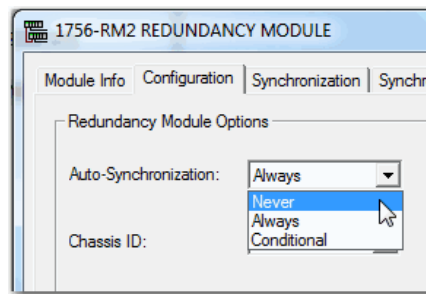
- a. Start RSLinx Classic Software.
 - b. Select Communications and choose RSWho.
 - c. Open the branches of your network until you find the 1756-RM or 1756-RM2 module in the primary chassis.
 - d. Right-click the 1756-RM or 1756-RM2 module, and choose Module Configuration.
8. On the Configuration tab, from the Auto-Synchronization pull-down menu, choose Never.

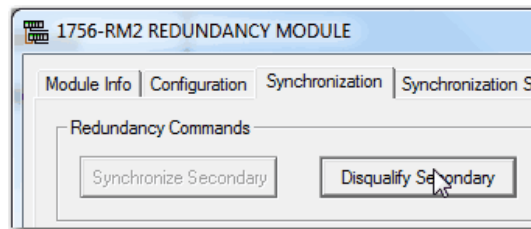
9. Click Apply and then Yes.
10. On the Synchronization tab, click Disqualify Secondary and then click Yes.

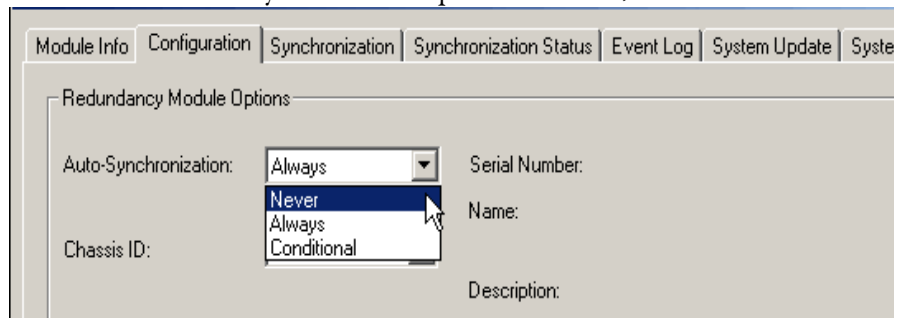
- Click the Configuration tab in the RMCT.
- From the Auto-Synchronization pull-down menu, choose Never.

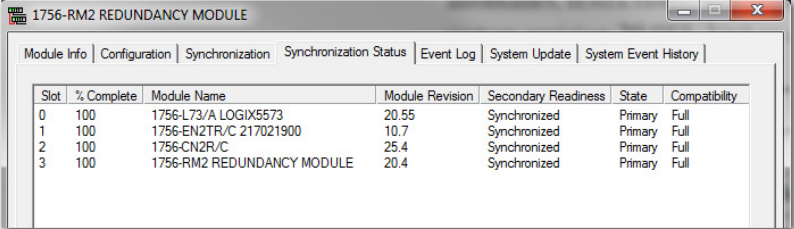
20. After the update completes, connect the Ethernet cable to the secondary Ethernet module, and wait for communication to resume on the network.
21. To verify that compatibility is Full for all communication modules in the chassis, check the Synchronization tab in the RMCT.

Slot	% Complete	Module Name	Module Revision	Secondary Readiness	State	Compatibility
0	100	1756-L73/A LOGIX5573	20.55	Synchronized	Primary	Full
1	100	1756-EN2TR/C 217021900	10.7	Synchronized	Primary	Full
2	100	1756-CN2R/C	25.4	Synchronized	Primary	Full
3	100	1756-RM2 REDUNDANCY MODULE	20.4	Synchronized	Primary	Full

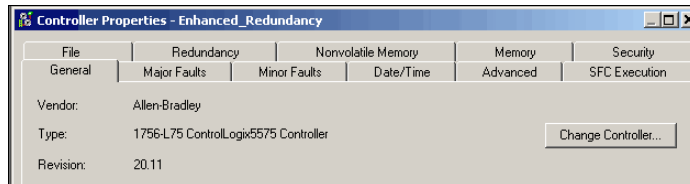
10. Click Change Controller.

11. Specify the controller revision that you are updating to.

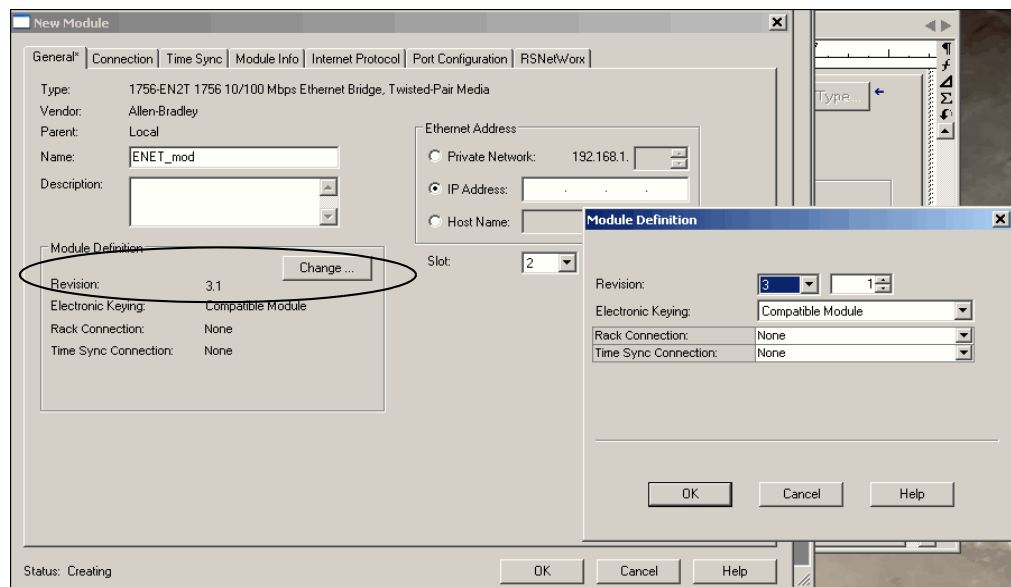
14. Access the Module Properties for each communication module in the chassis and specify the module firmware revision that you are updating to.

If you are unable to specify the new revision, you must change the Electronic Keying parameter to Compatible Keying.

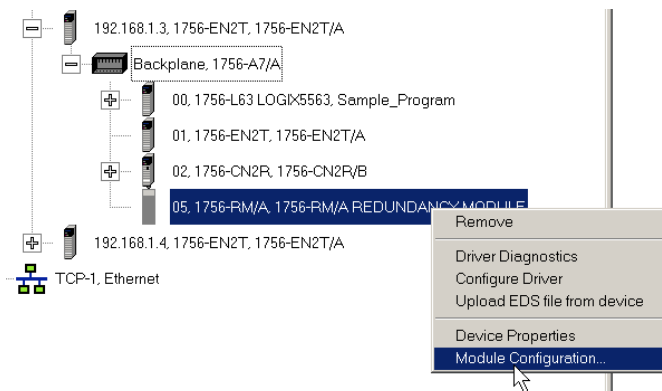
1. In RSLinx Classic software, right-click the 1756-RM or 1756-RMXT redundancy module in the primary chassis and choose Module Configuration to open the RMCT.

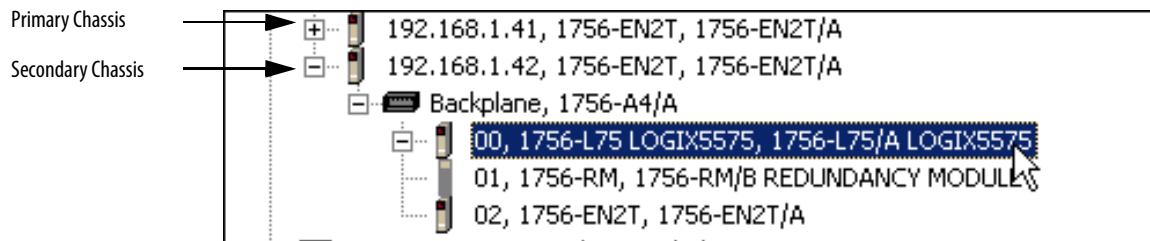
5. Browse to the module and select it.

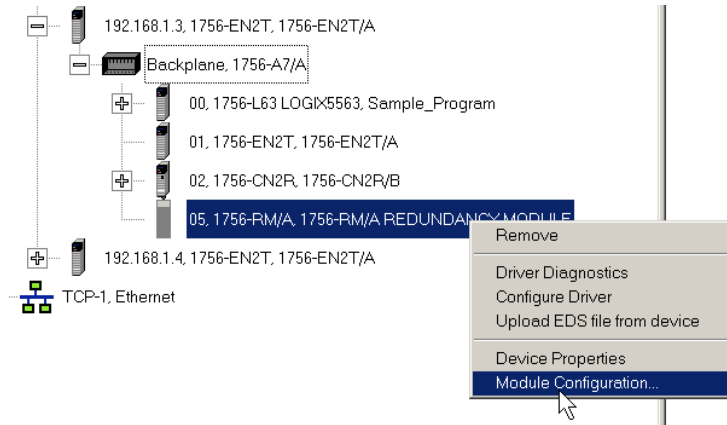
1. In RSLinx software, right-click the 1756-RM or 1756-RMXT module in the primary chassis and choose Module Configuration to open the RMCT.

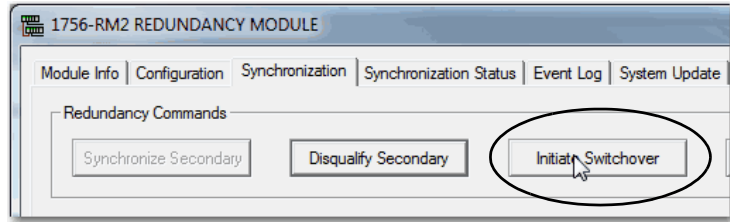
3. Initiate a switchover.

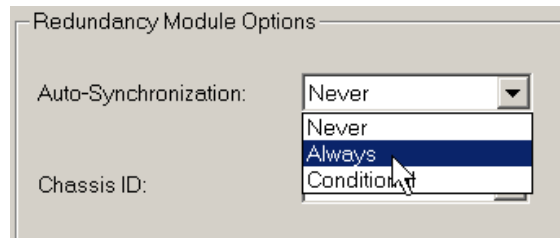
4. In the new secondary, set the rotary switches back to the original configuration.
5. Repeat this process for all Ethernet modules that need the rotary switches set back to 2...254.
6. From the Auto-Synchronization pull-down menu, choose the frequency that suits your application.

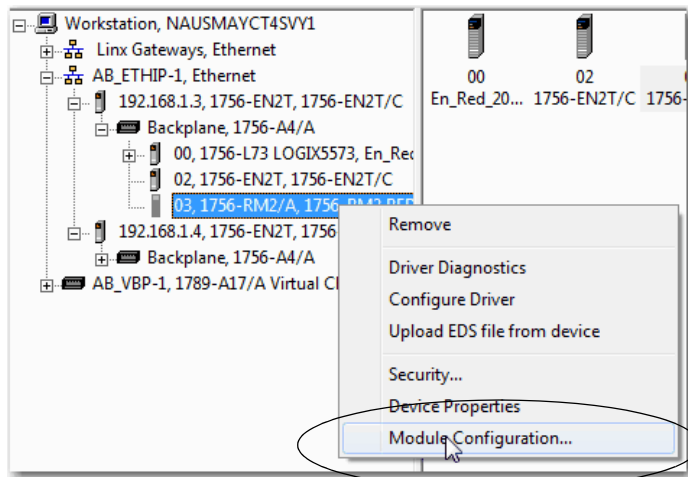
1. Open RSLinx Classic software and browse to the redundancy module.
2. Right-click the redundancy module in the primary chassis and choose Module Configuration.

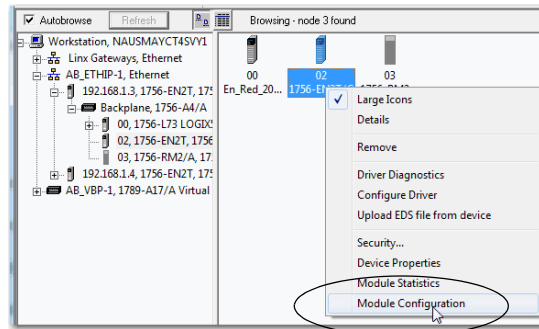
5. Click Apply, and then click Yes.
 6. Remove the secondary 1756-EN2T module from its chassis and disconnect the Ethernet cables from the module.
 7. Configure the IP address on the primary 1756-EN2T module.
- The following steps use RSLinx Classic software.
- a. Right-click the module icon and choose Module Configuration.

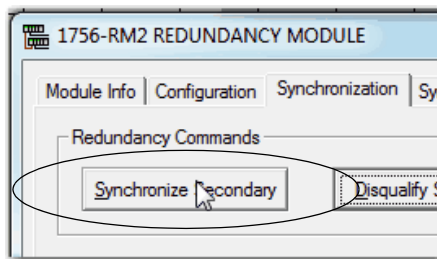
13. On the Synchronization tab in the RMCT, click Synchronize Secondary to synchronize the chassis.

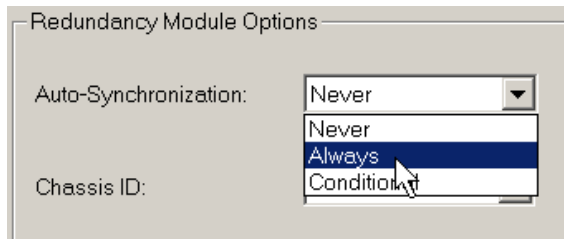
18. After the module resets, remove it again.
19. Set the rotary switches on the secondary module to the desired IP address.
20. Reinstall the module in the chassis and reconnect it to the network.
Any Duplicate IP address errors that existed previously are no longer present.
21. In the RMCT, from the Auto-Synchronization pull-down menu, choose your preferred method.

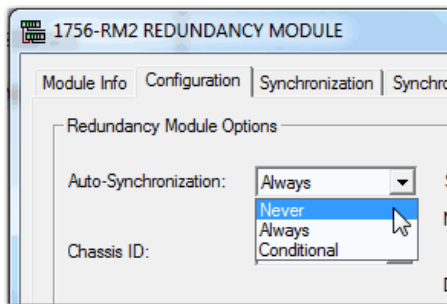
- From the Auto-Synchronization pull-down menu, choose Never.

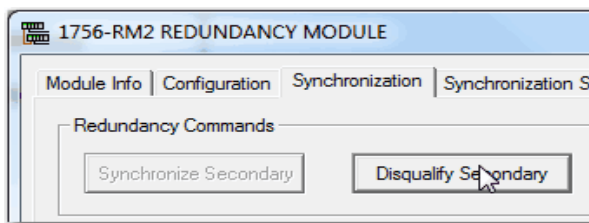
- Click Apply, and then click Yes.
- On the Synchronization tab, click Disqualify Secondary.

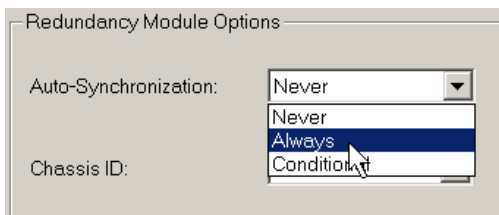
- In the RMCT, from the Auto-Synchronization pull-down menu, choose your preferred method.

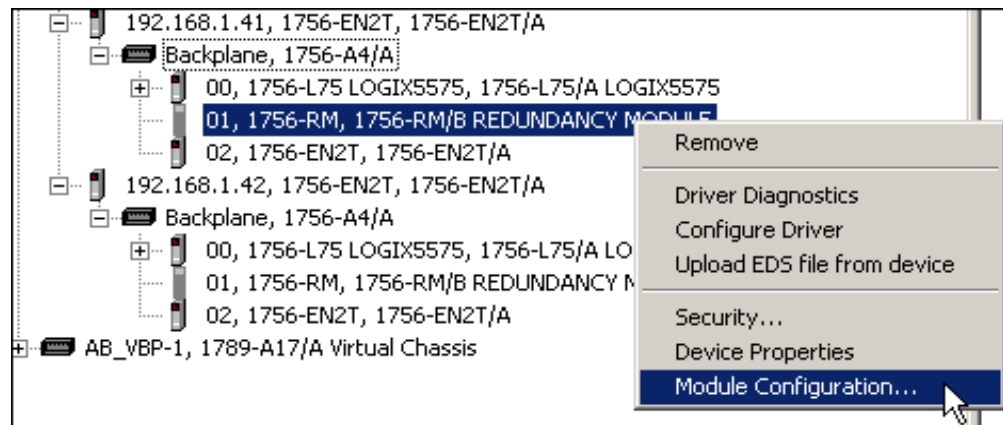
10. If you want to store the project to the nonvolatile memory card of the primary controller, execute a switchover as described in these steps.
- a. In RSLinx Classic software, right-click the 1756-RM module and choose Module Configuration to open the RMCT for the **primary** redundancy module.

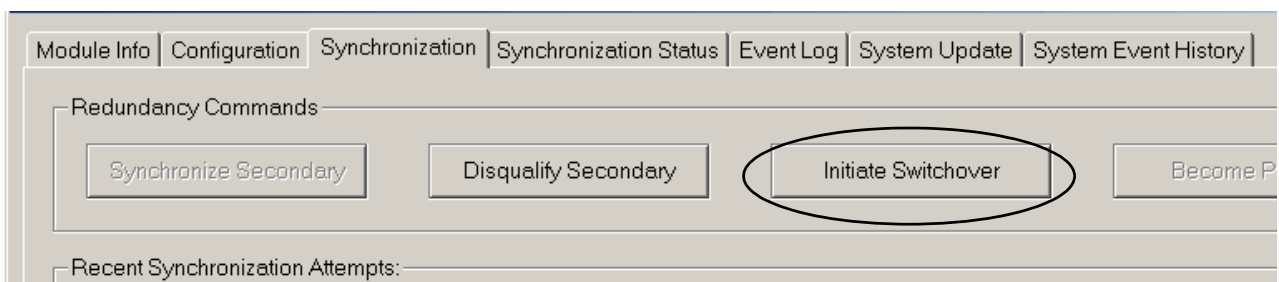
- b. Click the Synchronization tab.
- c. Click Initiate Switchover.
